FATALITY ASSESSMENT & CONTROL EVALUATION

A 14-year-old laborer crushed under 5-ton beam

FACE 01-AK-027

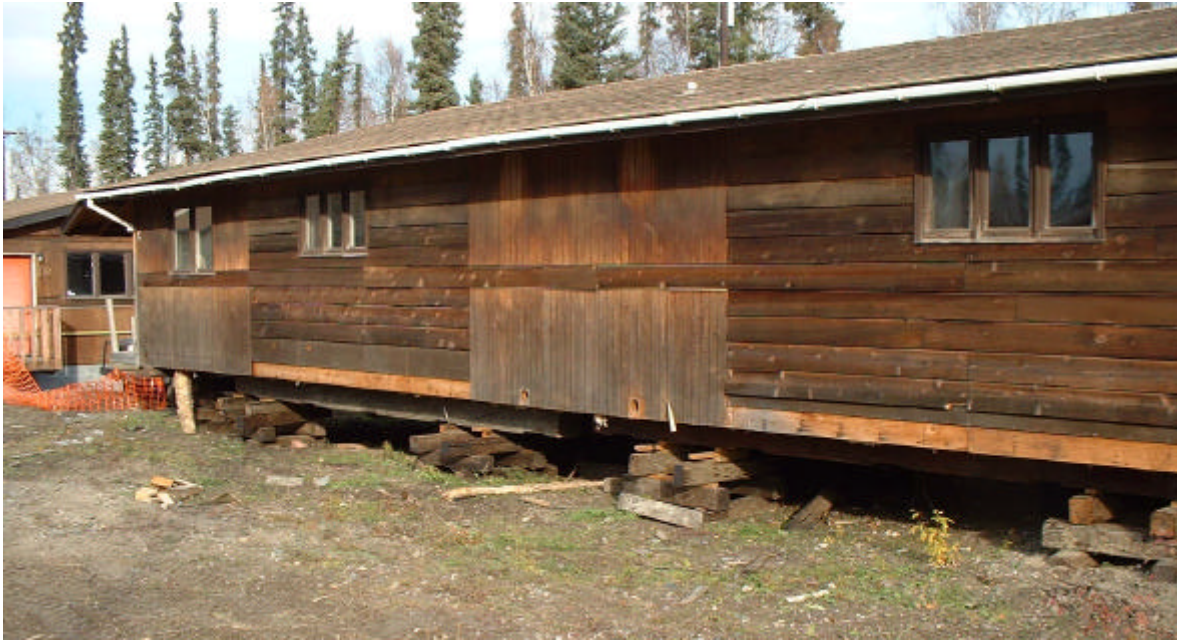
The incident site was in a residential lot with two multi-family residential buildings (four-plexes). Thirteen months prior to the incident, the two buildings were moved to the lot and left elevated approximately 3 feet above ground until a foundation could be built under each structure (Figure 1). The concrete block foundation of one building had been recently completed.

A second beam was beneath the adjacent building. The building was supported from underneath by several 12- by 12-inch wood support beams on top of stacks of 6- by 8-inch wood blocks or cross-supports (Figure 1). The supports were arranged in three rows, one on each side and one in the center. The beam appeared to have been dragged or rolled to its present location under the building. A chain was also on the ground under the house, parallel with the beam but on the opposite side of center supports. This was in preparation for moving the beam from under the first building (with the completed foundation) into position under the adjacent building.

Figure 1 Raised building supported by beams on wood blocks or cross supports

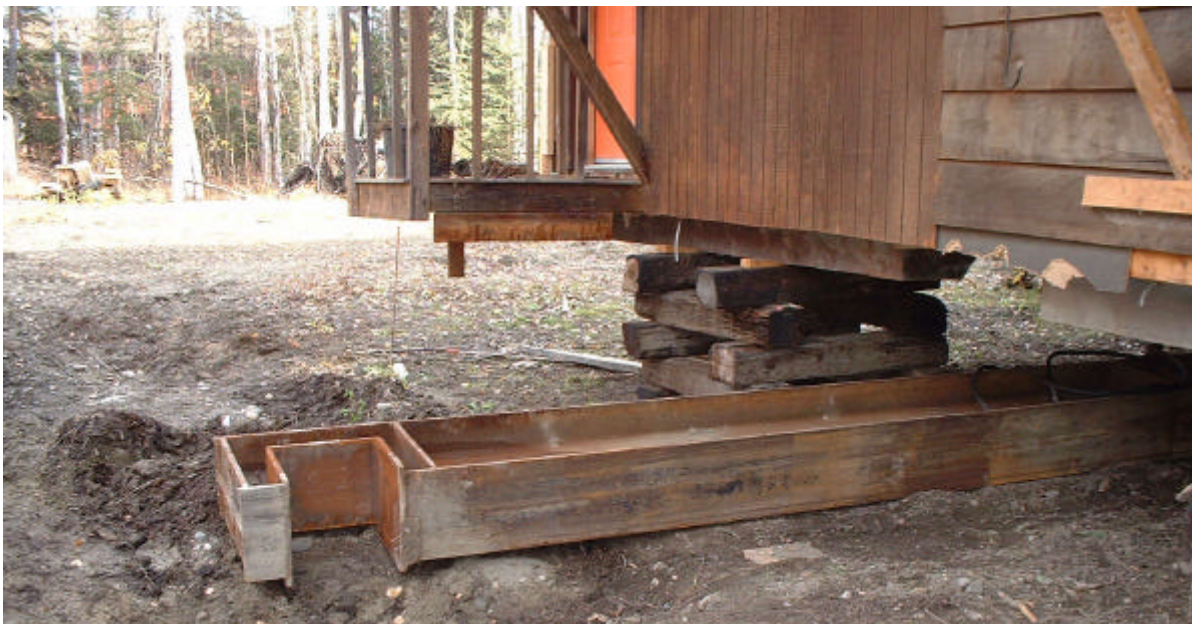
The company used two 79-foot metal beams to support the entire length of the structure when it was lifted and moved to its present location. The beams were 24½ inches tall with a central vertical support plate, and two 13 inches wide horizontal plates on the top and bottom (Figure 2). Each metal beam weighed approximately 5¼ tons. Prior to the incident, one building was lifted, supported, and then lowered for the necessary additional clearance to build a new concrete block foundation (Figure 3). A single metal beam remained under this building, extending past the foundation through openings in the foundation walls. Openings were left in the foundation walls so the beam could be pulled from underneath the building.

Figure 2. Beam position under raised building

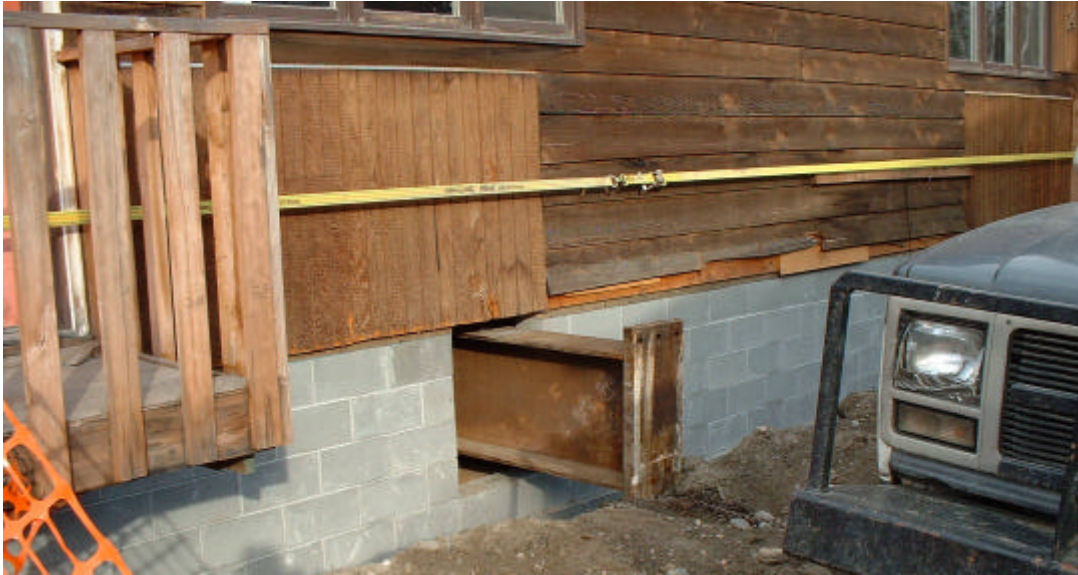
At the time of the incident, the victim was part of a three-man crew working beneath the second building; the company owner was working around the first building. The beam that had been relocated underneath the building had been pulled 3 feet past the building wall. Approximately 7½ feet of the beam remained on the opposite side (between the two buildings). The crew was working at this end of the beam; the victim was working on the opposite side of the beam from the other workers. His location was closest to the outside of the wall of the building; the other workers, on the opposite side of the beam, were near the center of the building. One worker was charged with setting, filling, and the deflating the airbag (Figure 4); the victim and the other worker placed wood blocking under the beam when lifted. They had successfully raised the beam 4 inches from the ground after the first lift and had begun the next lift.

Figure 3. Beam extending past concrete block foundation

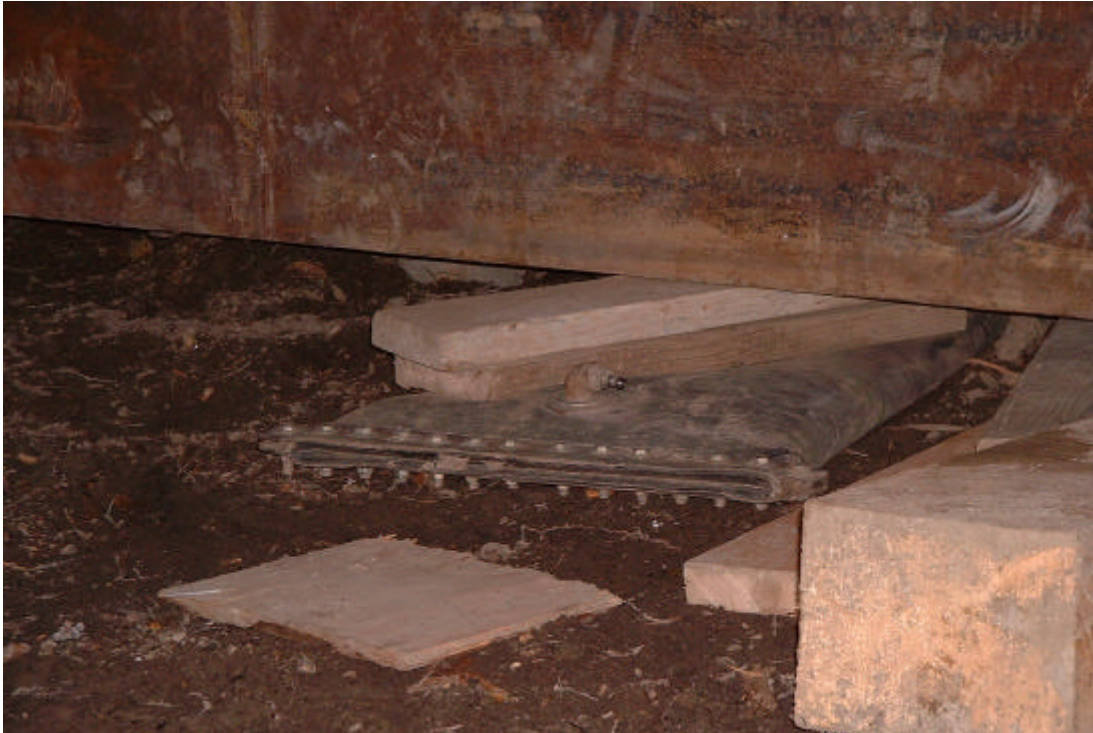
The lifting mechanism was a 2- by 3-foot airbag, used to initially raise the end of the beam. The use of airbags is an accepted standard industry practice and is considered less hazardous than hydraulic jacking. Each airbag can lift up to 100,000 pounds. Hydraulic jacks, used once the beam has been elevated into position to lift a structure, are considered a higher risk due to potential slippage and vertical instability of the jack (which is normally blocked as a preventive measure). Each airbag has the ability to provide 12 inches of lift; eight inches of lift was considered standard working height. The airbag filled and lifted the beam in approximately one minute. Once the beam is raised, a block of wood (6- by 8-inch or 8- by 8-inch) is slid beneath

The beam was lifted approximately eight inches above the first blocks of wood. The victim was kneeling next to the beam and was either reaching for a wood block or was attempting to push the block under the beam when the beam rolled off the airbag. The beam fell across the victim's back pinning him in a kneeling position against the ground. The other workers immediately called for help. As the worker in-charge of the airbag was attempting to deflate and reposition the bag, the second went to collect a hydraulic jack and a skid steer loader to lift the beam, if necessary. Hearing the cries for help, the company owner crawled under the building and assisted with the inflation of the airbag and pulled the victim from beneath the beam. A cell phone found on the victim was used to call 911.

Figure 4. Airbag used to lift beam

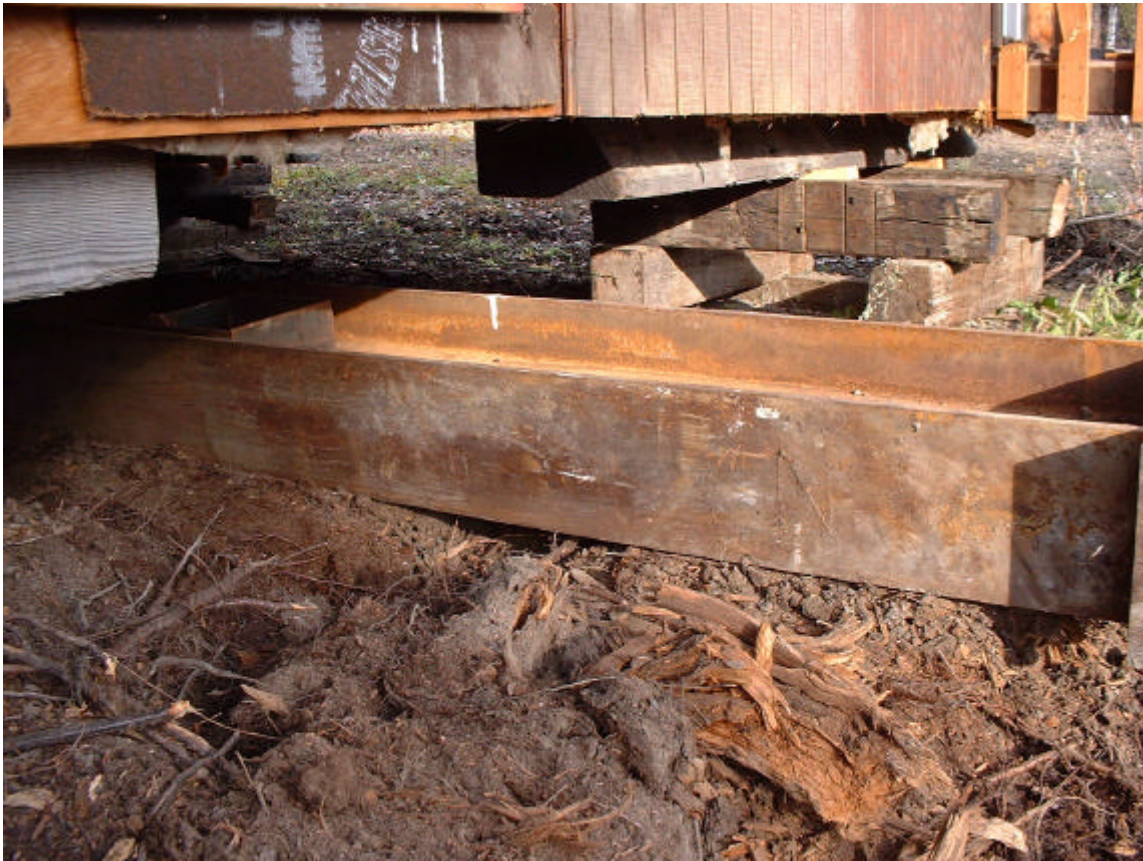
Comments made immediately following the incident to responding emergency personnel indicated that immediately prior to the incident the beam seemed to be slightly "warped" or tilted at the far end of the beam while it appeared to be level and upright where the crew was working. The injury prevention specialist for the Alaska Department of Health and Social Services, Section of Epidemiology, and an investigator for the Alaska Department of Labor and Workforce Development inspected the work area and the ground under the beam extending past the building. The far end of the beam was found adjacent to a buried stump (Figure 5). When upright, the beam would have been resting on the top of stump. It was surmised that the stump had been graded over during the excavation of the lot. Possibly the weight of the beam as it was tipped up during the lift crushed the remainder of the stump, causing the beam to become unstable and roll.

Figure 5. Stump and root material under beam

Discussion: Employers should conduct an initial inspection of the ground to identify potential hazards such as materials that may have been bladed over and not removed. In many municipalities, all stumps and roots must be removed from the soil to a depth of at least 12 inches below the surface of the ground in the area to be occupied by the structure or building.
